FINDING OF COMPLIANCE

Staff from the Missouri Department of Natural Resources conducted an audit from April 12 through May 5, 2022, of the Missouri Department of Transportation Separate Storm Sewer System and Area Wide Land disturbance program. These programs operate under the authority of Missouri State Operating Permit (permit) MO-0137910.

**Missouri Department of Natural Resources
Water Protection Program
Report of Inspection
Missouri Department of Transportation
P.O. Box 270, Jefferson City, MO 65102
Cole County, MO
July 29, 2022**

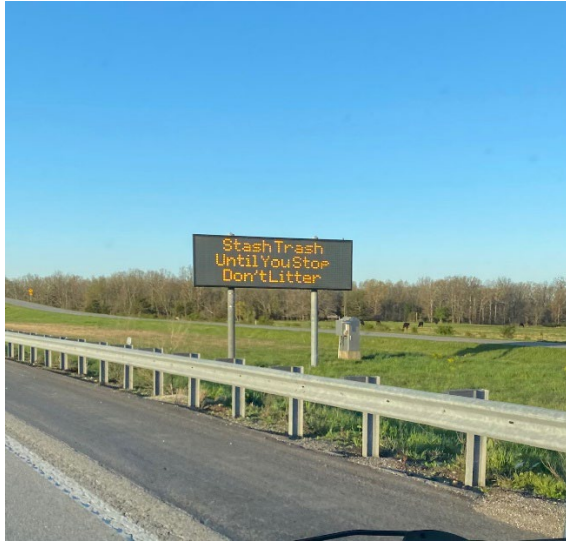
Photograph: #01
Taken By: Erin Heidolph
Date Taken: April 26, 2022
Program: WPP

Description: Dynamic Message Board showing anti-litter message.

MoDOT is constantly re-evaluating and modifying their Education and Outreach Program with new iterations in content in an effort to ensure the educational message is fresh and focused on MoDOT's areas of concern and target audiences. For example, one of MoDOT's educational tools utilized during outreach events, such as the State Fair and Earth Day, is a beanbag toss game with the holes in the board located on scenes depicting areas of stormwater pollution sources. The first iteration of this beanbag game board was focused on general stormwater. The second iteration focused more on the TS4 pollution sources. This is also an excellent example of the iterative process and adaptive management of MoDOT's Education and Outreach Program. MoDOT does not currently track the utilization of interstate billboards or Dynamic Message Boards in their Education and Outreach Program. However, they are investigating the ability to track educational messages on billboards/message boards as a BMP for their Education and Outreach Program. They are also looking into the possibility of utilizing Public Service Message videos or educational brochures at locations, such as Department of Motor Vehicle offices and interstate rest areas with video capabilities and/or dedicated public information displays/repositories. (Photo #01)

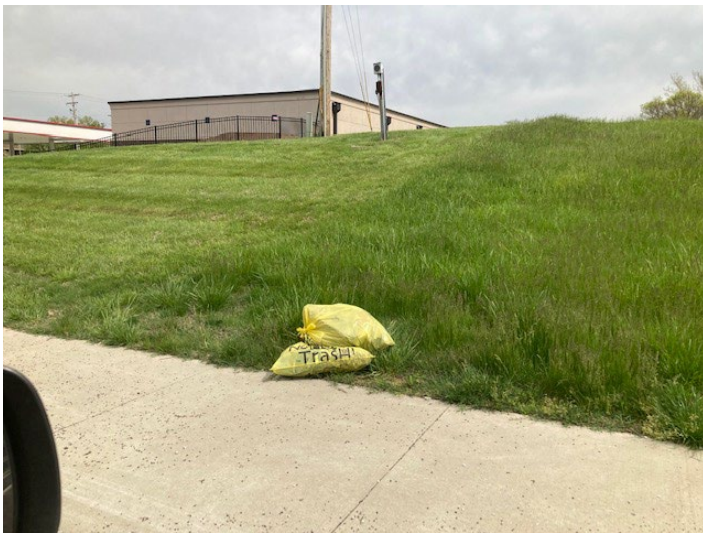
Photograph: #02
Taken By: Sarah Wright
Date Taken: May 2, 2022
Program: WPP

Description: No MOre Trash bags from clean up, MoDOT picks up the bags after the cleanup.

Each of MoDOT’s BMPs have quantitative measureable goals evaluated on an annual basis to determine the success of the BMPs performance or the need for modification or replacement of the BMP. MoDOT successfully met each BMP’s Measurable Goal(s) within this MCM except for the Measurable Goal of seeing a positive trend for stormwater concern reports received through the “Report a Stormwater Concern” form, as previously mentioned under MCM 1. The remainder of MoDOT’s BMPs performed as expected. MoDOT did note some BMPs such as the No More Trash Bash, the Adopt-A-Highway and the Sponsor-A-Highway Programs exceeded expectations despite complications from the COVID-19 pandemic. (Photo #002)

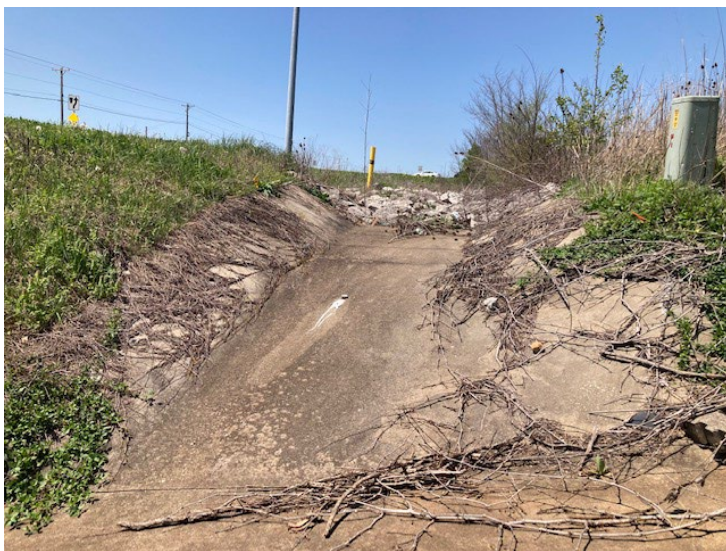
Photograph: #03
Taken By: Sarah Wright
Date Taken: April 26, 2022
Program: WPC Unit

Southwest District – On April 26, outfall number 1270 was observed. Rock-lined ditch to box culvert located at N. 22nd St. and W. Jackson Rd (Hwy 14), Ozark, Christian County. Tributary to Finley Creek. Outfall was observed to be dry with no visual concerns present. (Photo #03)

Description: Outfall to Tributary to Finley Creek.

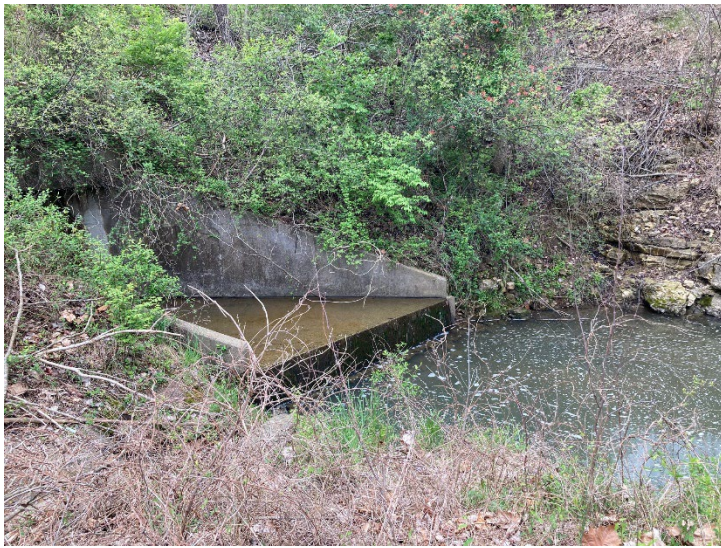
Photograph: #04

Central District – On May 2, outfalls number 602 and 603 were observed. Ditches to concrete pipe with flared outlet located off of Raptor Rd./Red Eagle adjacent to 5621 Raptor Rd., Jefferson City, Cole County. Tributary to Binder Lake. The area received significant rain over the weekend. Clear, unremarkable water was observed flowing from the outfall. (Photo #04)

Description: Outfall to Tributary to Binder Lake.

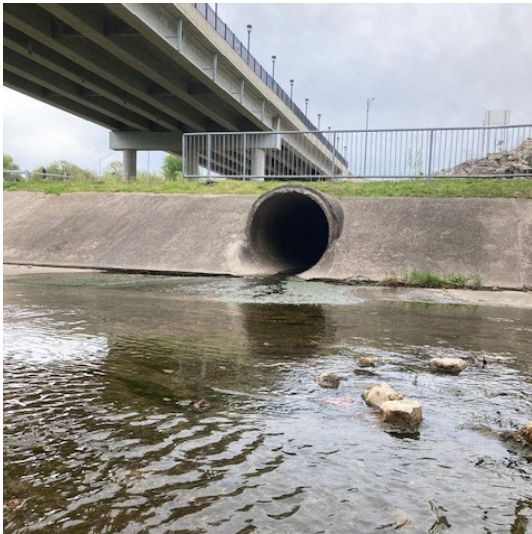
Photograph: #05

On the same day, outfall number 6935 was observed. Concrete pipe outfall located adjacent to E. Elm St. and Marshall St. and Lewis and Clark Trail (Hwy 50/63), Jefferson City, Cole County. Tributary to Wears Creek. The area received significant rain over the weekend. Clear, unremarkable water was observed flowing from the outfall. (Photo #05)

Description: Outfall to Tributary to Wears Creek.

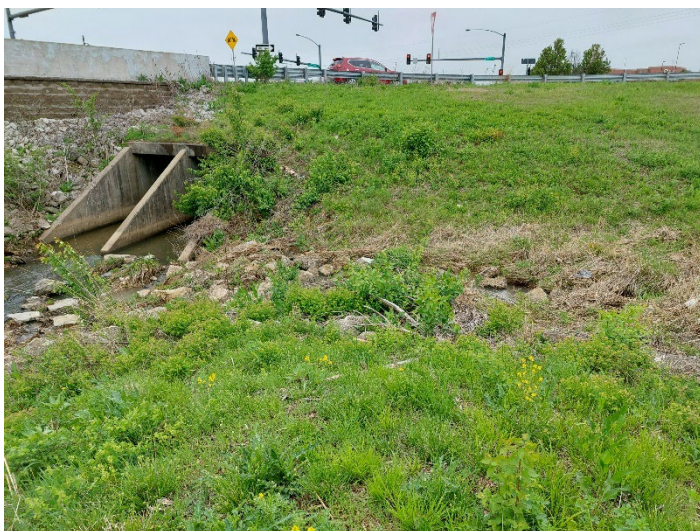
Photograph: #06

St. Louis District – On May 3, outfalls 1053 (pipe) and 1054 (rock-lined ditch) were observed, located on the east side of Sommers Rd. adjacent to QuikTrip 8334 Hwy N, Lake St. Louis, St. Charles County. Tributary to Dardenne Creek. Outfall was observed to be dry with no visual concerns present. (Photo #06)

Description: Rock-lined ditch outfall to Tributary to Dardenne Creek.

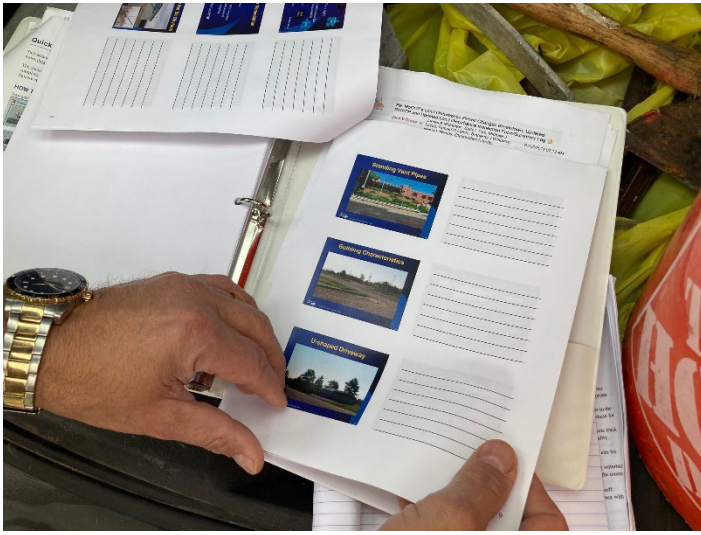
Photograph: #07
Taken By: Sarah Wright
Date Taken: April 26, 2022
Program: WPP

Description: Binder showing proper installation or maintenance of BMPs

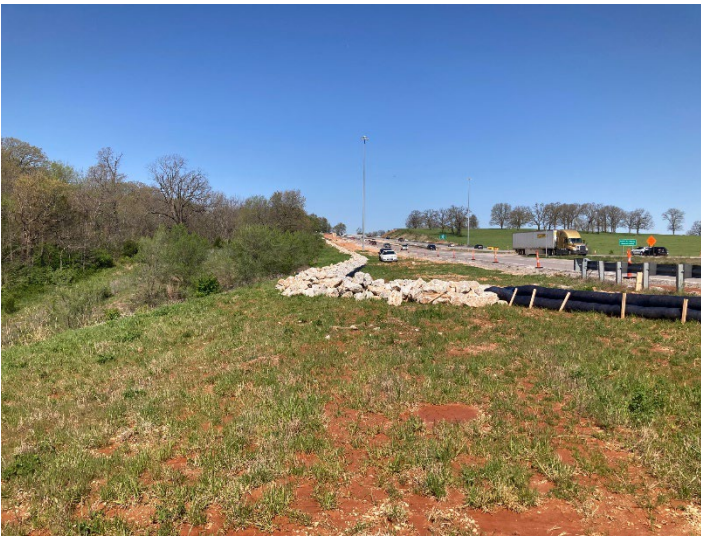
Photograph: #08
Taken By: Sarah Wright
Date Taken: April 26, 2022
Program: WPP

MCM 4 oversight inspection, Southwest District – April 26, 2022 an oversight inspection was conducted on Project Contract ID 201120-G10, the Highway 65 interchange reconfiguration project. This oversight inspection was conducted by Ashley McDaniel and Chris Miller. The inspector and inspection procedures were found to be in compliance with the conditions of the Permit. (Photo #08). A full report was issued by the SWRO.

Description: Edge of disturbance top of slope.

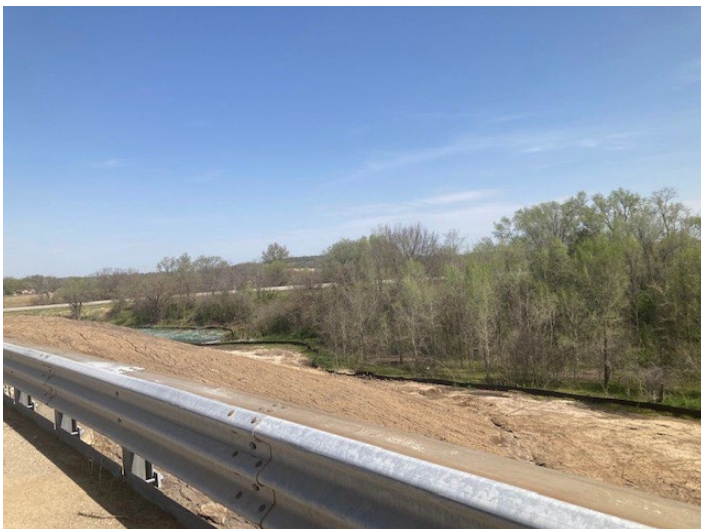
Photograph: #09
Taken By: Sarah Wright
Date Taken: April 27, 2022
Program: WPP

MCM 4 Kansas City District – April 27, 2022 an oversight inspection of Project Contract ID 201218-C04 Jackson County bridge replacement on Highway 24 was conducted. This oversight inspection was conducted by Sarah Wright and Adria Palmer. The inspector and inspection procedures were found to be in compliance with the conditions of the Permit. (Photo #09)

Description: Looking over disturbance.

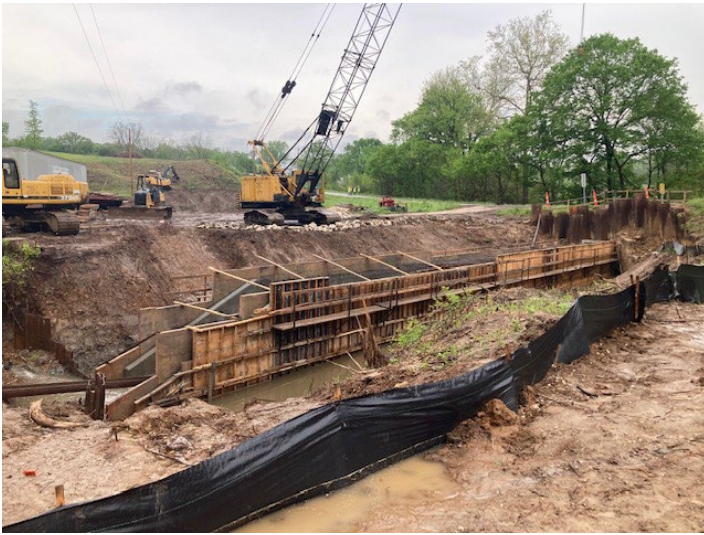
Photograph: #10
Taken By: Sarah Wright
Date Taken: April 26, 2022
Program: WPP

Area-wide Land Disturbance inspection, Southeast District – May 5, 2022 an inspection of Project Contract ID 211119-H10, Route A, west of Wittenberg, in Perry County was conducted by Crosley Welch and Elizabeth Stephens. The site was found to be in compliance with the conditions of the Permit. (Photo #10) A full report was issued by the SERO.

Description: Facing Disturbance.

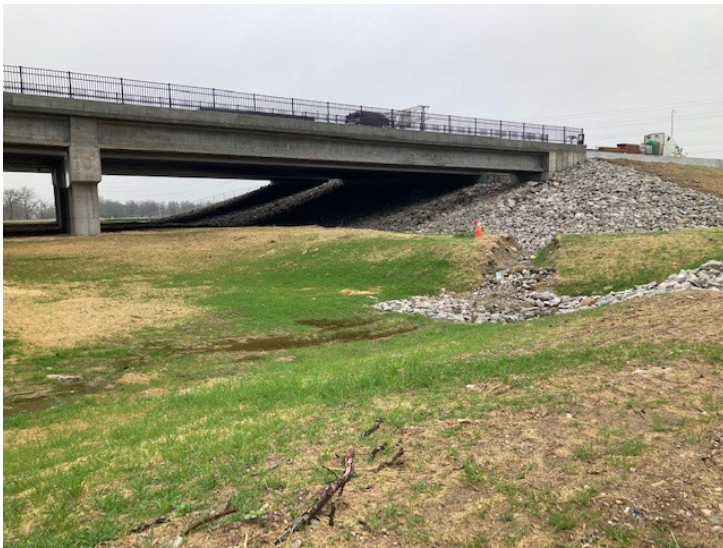
Photograph: #11
Taken By: Sarah Wright
Date Taken: May 2, 2022
Program: WPP

Description: Not yet completed basin, construction not finalized.

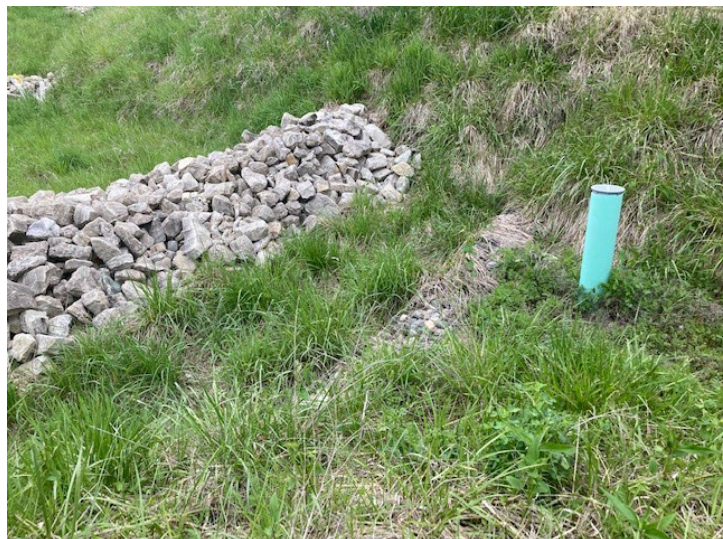
Photograph: #12
Taken By: Sarah Wright
Date Taken: May 2, 2022
Program: WPP

Description: Focal Point post-construction BMP.

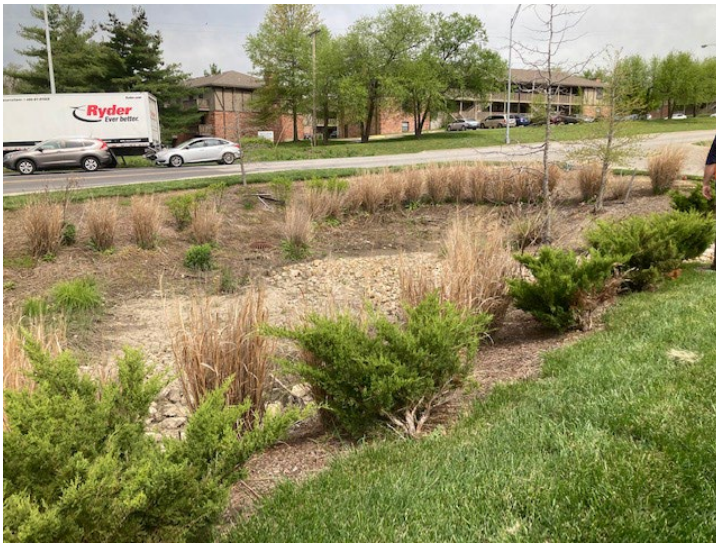
Photograph: #13

Description: Bio-retention, maintained by the City of Columbia.

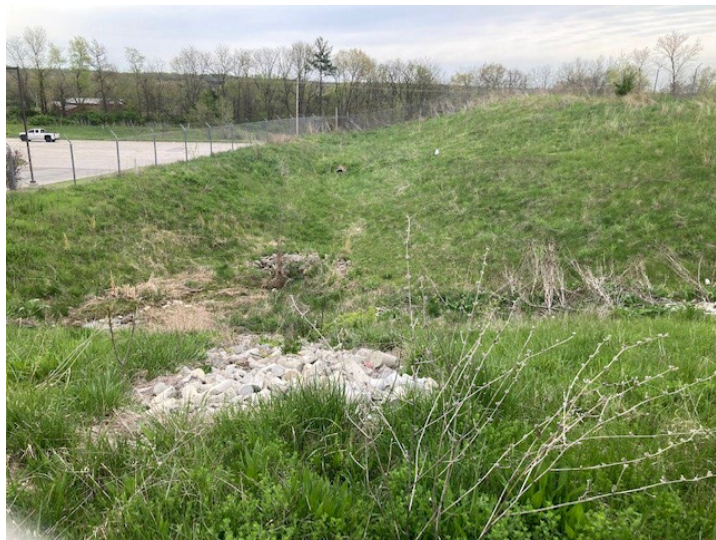
Photograph: #14

Description: Check dam into large basin.

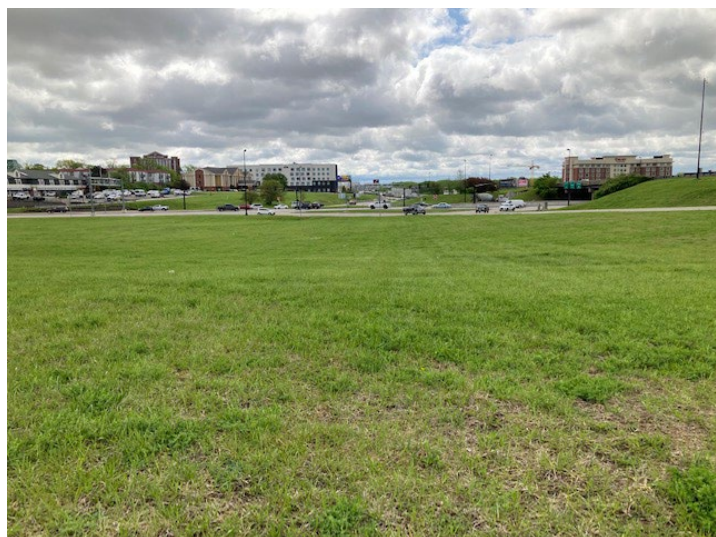
Photograph: #15

Description: Large basin. Uses the space, and the depression to collect a large amount of runoff from the surrounding roadways.

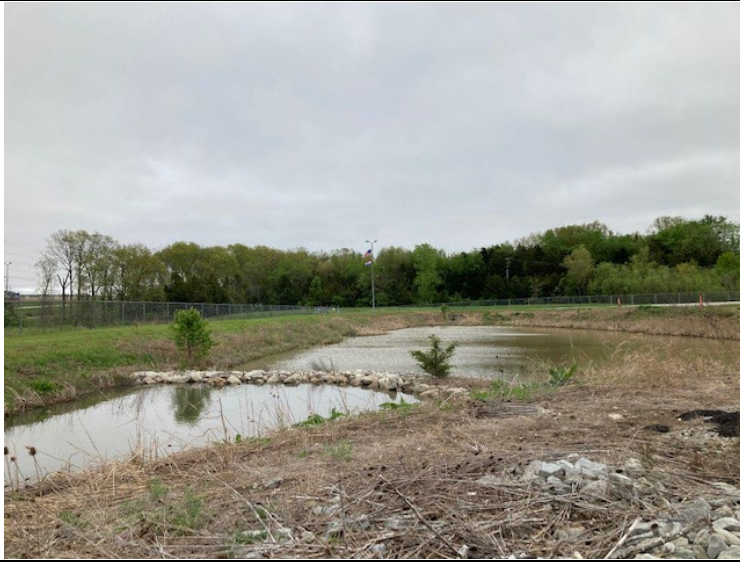
Photograph: #16
Taken By: Sarah Wright
Date Taken: May 3, 2022
Program: WPP

Description: Forebay with riprap to separate from basin. Outlet at the far end.

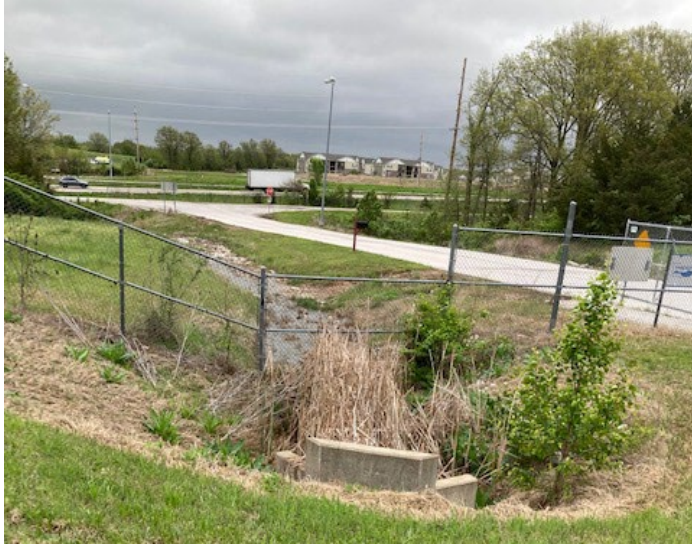
Photograph: #17
Taken By: Sarah Wright
Date Taken: May 3, 2022
Program: WPP

Description: Outfall of the basin, water discharging to swale of rock.

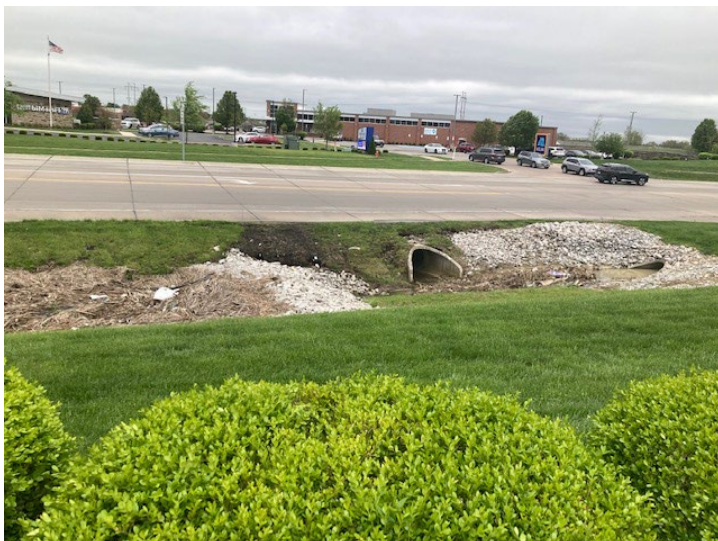
Photograph: #18
Taken By: Sarah Wright
Date Taken: May 3, 2022
Program: WPP

May 3, 2022, Lake St. Louis, St. Charles County, West of Interstate 64 at the Route 364 and Highway N intersection. (Photo #18) This was a large swale with rock checks. It wrapped around part of a gas station, giving it the capacity to capture the runoff from the surrounding roadways. Some accumulated litter was present; however, the structure was in good condition.

Description: This was a large swale with rock checks.

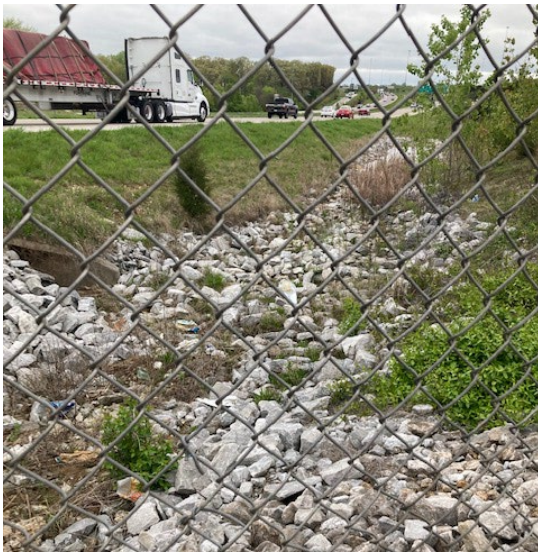
Photograph: #19
Taken By: Sarah Wright
Date Taken: May 3, 2022
Program: WPP

May 3, 2022, St. Charles County, between North Outer Forty Road and westbound Interstate 64. (Photo #19). This was a small ditch with rock checks. It is located off the interstate near a commuter lot. It had some accumulated litter, but the structure was in good condition.

Description: Rock swale, near commuter lot.

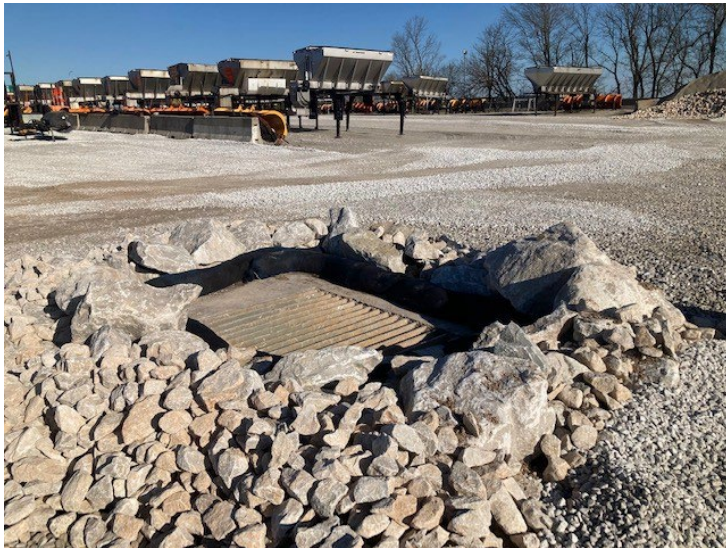
Photograph: #20
Taken By: Sarah Wright
Date Taken: April 26, 2022
Program: WPP

Description: Area inlet properly protected with riprap and gravel. Note organized lot, no issues found.

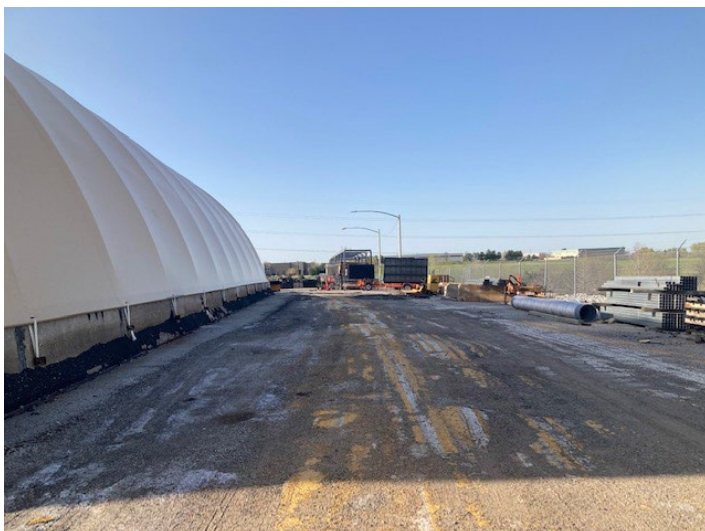
Photograph: #21
Taken By: Sarah Wright
Date Taken: April 27, 2022
Program: WPP

Description: Clean lot, substantial BMPs. No issues found.

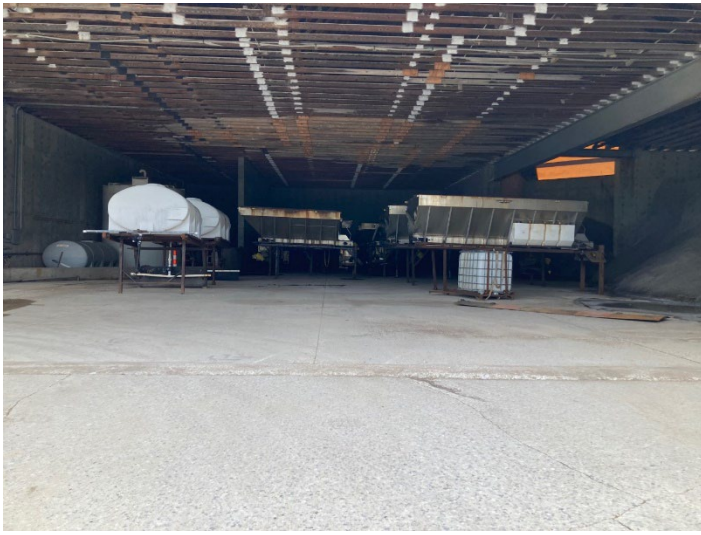
Photograph: #22

Description: Substantial permanent cover for equipment. Exceptionally organized facility, no issues found.

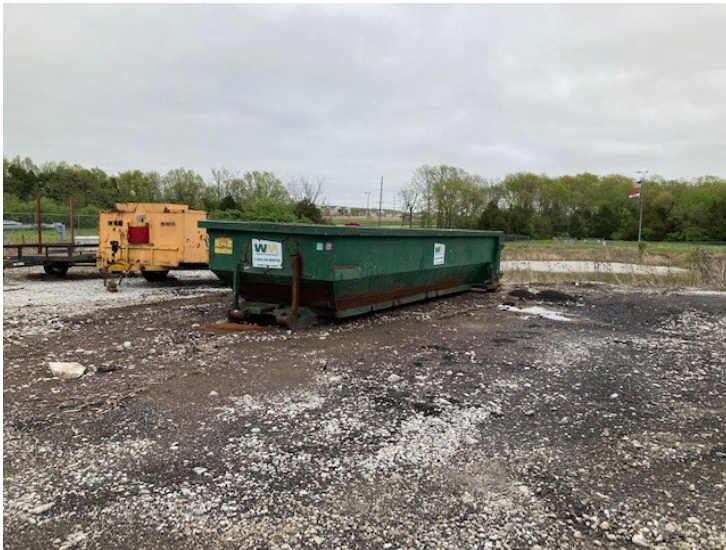
Photograph: #23

Description: Dumpster for road kill carcasses. No issues found at facility.

- 5) Ensure facility inspections look at dumpsters used for roadkill carcass disposal. Any leaks from those structures should be handled with applicable BMPs until a suitable replacement dumpster can be obtained.

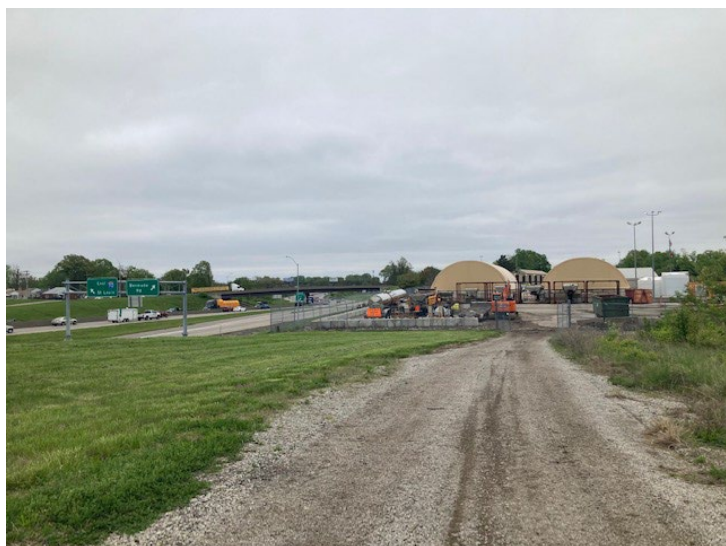
Photograph: #24

Description: Well-maintained facility, no issues found.

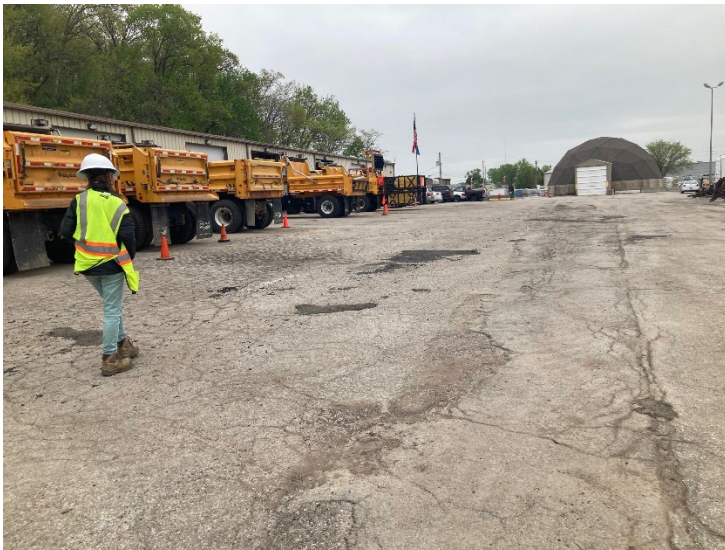
Photograph: #25
Taken By: Sarah Wright
Date Taken: April 26, 2022
Program: WPP

May 4, 2022, St. Louis District, Sunset Hills, St. Louis County. (Photo #25) This was a large facility. The facility was very well kept, and the records were nicely organized. There were no issues found at this location.

Description: Large open facility, well maintained. No issues found.

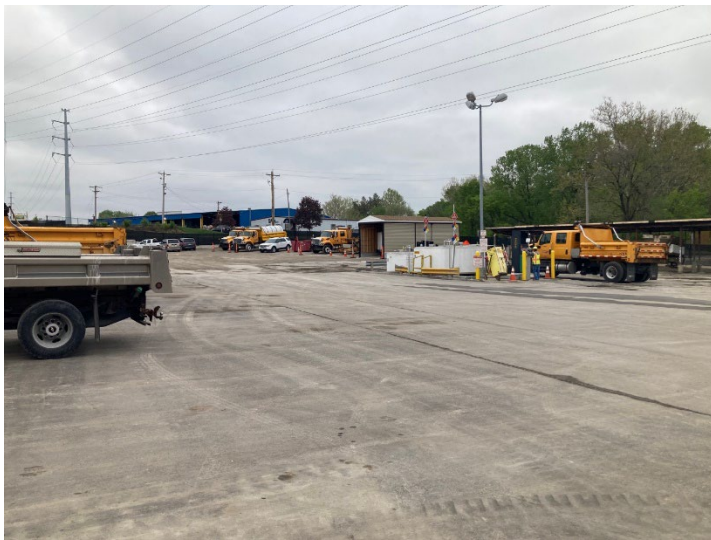
Photograph: #26
Taken By: Sarah Wright
Date Taken: May 2, 2022
Program: WPP

Description: Clean organized facility. No issues found.

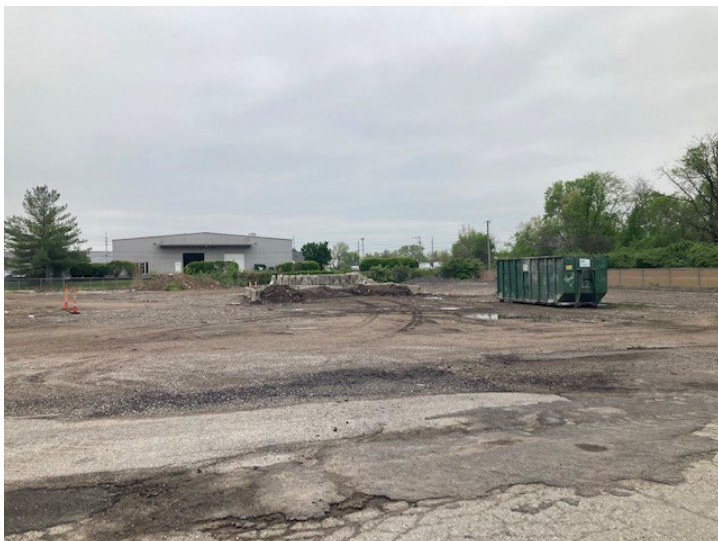
Photograph: #27
Taken By: Sarah Wright
Date Taken: April 26, 2022
Program: WPP

The FRCP plans and inspection reports were all well-kept, and showed the consideration to good housekeeping each facility maintains. Overall each facility had a strong understanding of appropriate BMPs, maintained proper procedures for equipment washing and storage, and maintained their yards to the best of their ability. There were some issues with the condition of the pavement at a few of the yards. (Photo #27) **(See Recommendations #5-#6 below)**

6) Consider re-paving of already paved areas in MoDOT facility yards. Often gravel is a more suitable surface as it absorbs more runoff and any potential spills or leaks. However, it is understood that is not always the preferred surface. For facilities that have been paved, it is important to maintain that surface. When pavement breaks down, it breaks into sediment which is a pollutant that easily leaves the site. This pavement sediment is a large contributor to stream sediment. Asphalt sediment often contains metals and polycyclic aromatic hydrocarbons (PAHs). By maintaining the pavement, the amount of sediment being washed off the site due to broken pavement will be reduced.
